# Boiler Plate Report

Filepath: 2D Demo Part.plr  
Customer: Costumer Industries  
Operator: Admin  
Inspection Date: 03/11/2020 (12:26:58)  
Works Order No: WON-Nr1295-b  
Customer Order No: CoNo1265-h  
Part No: PaNo2654  
Customer Part No: CPN-5699866  
Pass/Fail: Pass  
Report Summary: Items Passed: 32    Items Failed: 0    Items Missing: 0    Extra Holes: 0  
Part Thickness: Nominal: 2    Measured: 2    Deviation: 0

# Bolier Plate Report

Filepath: 2D Demo Part.plr  
Customer: Costumer Industries  
Operator: Admin  
Inspection Date: 03/11/2020 (12:26:58)  
Works Order No: WON-59986H  
Customer Order No: CON-25-hA  
Part No: PaNo15686  
Customer Part No: CPN-ABX-695  
Pass/Fail: Fail  
Report Summary: Items Passed: 22    Items Failed: 5    Items Missing: 0    Extra Holes: 0  
Part Thickness: Nominal: 2    Measured: 2    Deviation: 0

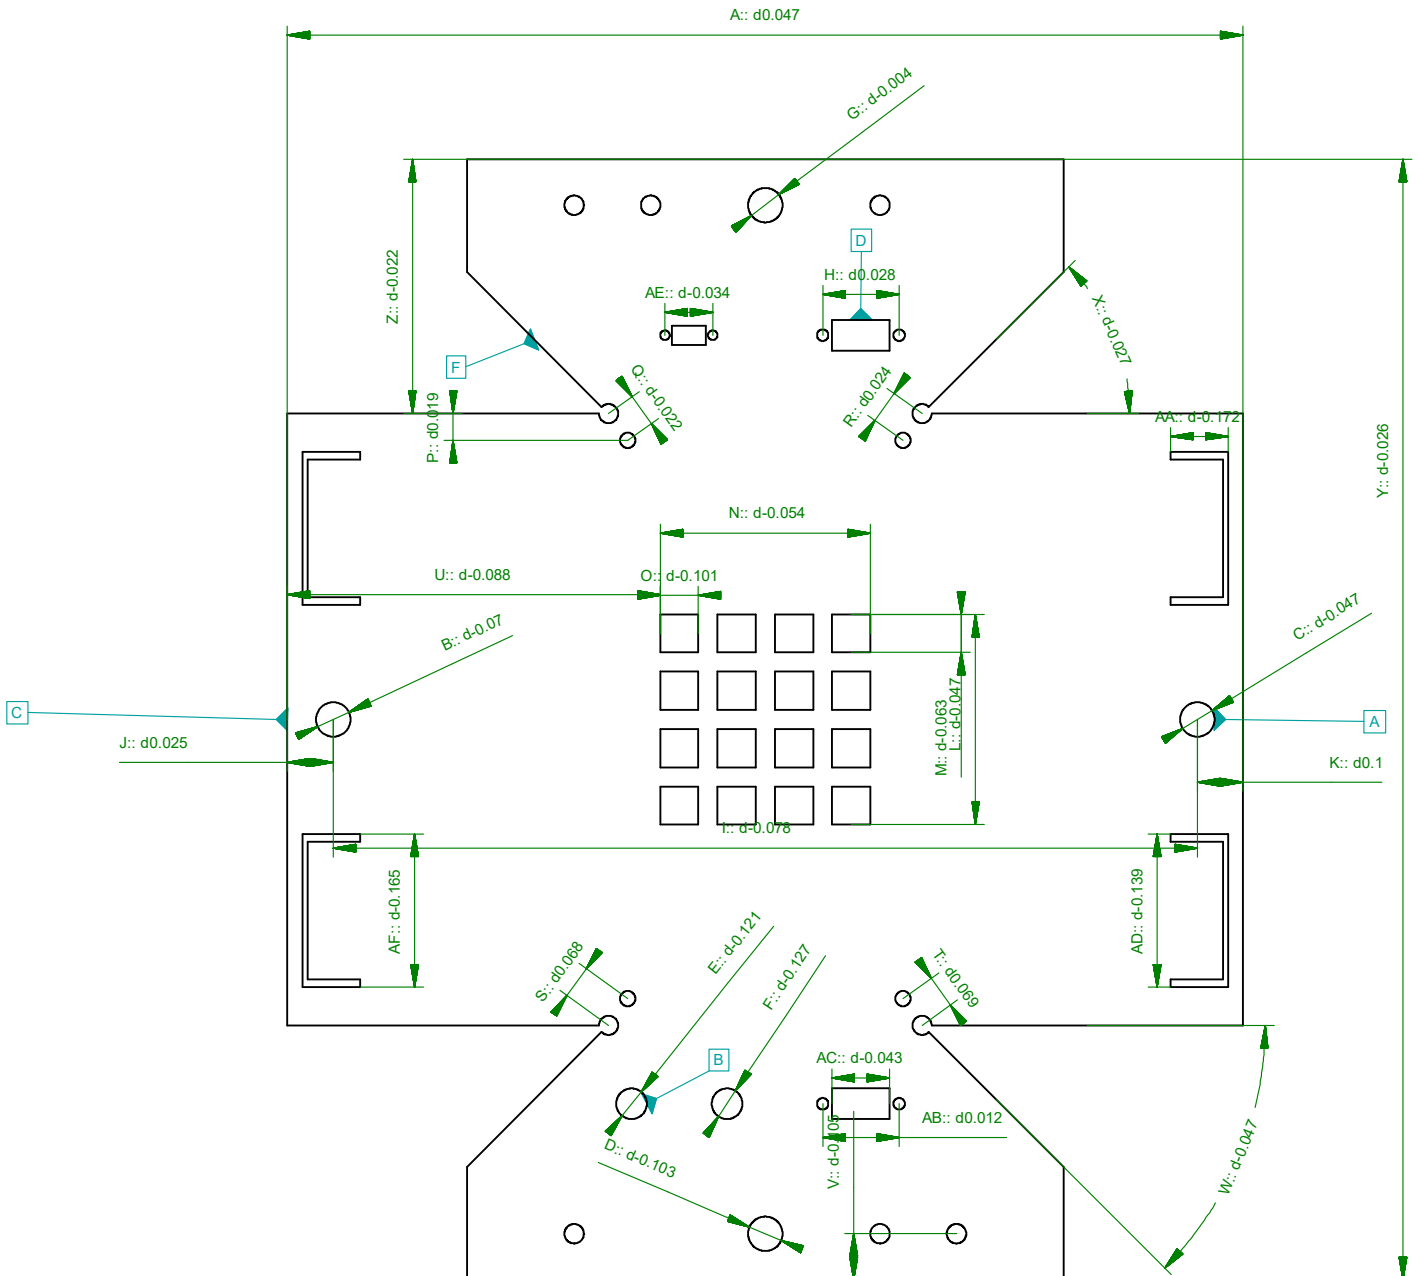
Name	Entity	Datum	Type	Nominal	Measured	Deviation	Standard deviation	Tolerance	Alignment	Status
A	Line	Line	Dist	250	250.047	0.047	0.028	+/-0.5	Global	Pass
B	Circle	Circle	Dia	9	8.93	-0.07	0.032	+/-0.2	Global	Pass
C	Circle	Circle	Dia	9	8.953	-0.047	0.045	+/-0.2	Global	Pass
D	Circle	Circle	Dia	9	8.897	-0.103	0.059	+/-0.2	Global	Pass
E	Circle	Circle	Dia	8	7.879	-0.121	0.055	+/-0.2	Global	Pass
F	Circle	Circle	Dia	8	7.873	-0.127	0.066	+/-0.2	Global	Pass
G	Circle	Circle	Dia	9	8.996	-0.004	0.035	+/-0.2	Global	Pass
H	Circle	Circle	Dist	20	20.028	0.028	0.072	+/-0.2	Global	Pass
I	Circle	Circle	Dist	226	225.922	-0.078	0.039	+/-0.5	Global	Pass
J	Line	Circle	Dist	12	12.025	0.025	0.03	+/-0.2	Global	Pass
K	Circle	Line	Dist	12	12.1	0.1	0.037	+/-0.2	Global	Pass
L	Line	Line	Dist	55	54.953	-0.047	0.035	+/-0.3	Global	Pass
M	Line	Line	Dist	10	9.937	-0.063	0.058	+/-0.2	Global	Pass
N	Line	Line	Dist	55	54.946	-0.054	0.027	+/-0.3	Global	Pass

O	Line	Line	Dist	10	9.899	-0.101	0.024	+/-0.2	Global	Pass
P	Line	Circle	Dist	6.999	7.018	0.019	0.061	+/-0.2	Global	Pass
Q	Circle	Intersection	Dist	8.602	8.58	-0.022	0.044	+/-0.2	Global	Pass
R	Intersection	Circle	Dist	8.602	8.626	0.024	0.029	+/-0.2	Global	Pass
S	Circle	Intersection	Dist	8.603	8.671	0.068	0.035	+/-0.2	Global	Pass
T	Intersection	Circle	Dist	8.602	8.671	0.069	0.042	+/-0.2	Global	Pass
U	Line	Line	Dist	97.5	97.412	-0.088	0.029	+/-0.3	Global	Pass
V	Circle	Line	Dist	12	11.895	-0.105	0.032	+/-0.2	Global	Pass
W	Line	Line	Degrees	45	44.953	-0.047	0.028	+/-0.5	Global	Pass
X	Line	Line	Degrees	45	44.973	-0.027	0.02	+/-0.5	Global	Pass
Y	Line	Line	Dist	293.003	292.977	-0.026	0.021	+/-0.5	Global	Pass
Z	Line	Line	Dist	66.502	66.48	-0.022	0.05	+/-0.3	Global	Pass
AA	Intersection	Intersection	Dist	15	14.828	-0.172	0.023	+/-0.2	Global	Pass
AB	Circle	Circle	Dist	20	20.012	0.012	0.078	+/-0.2	Global	Pass
AC	Line	Line	Dist	15	14.957	-0.043	0.036	+/-0.2	Global	Pass

AD	Intersection	Intersection	Dist	40	39.861	-0.139	0.025	+/-0.3	Global	Pass
AE	Circle	Circle	Dist	12.5	12.466	-0.034	0.06	+/-0.2	Global	Pass
AF	Intersection	Intersection	Dist	40	39.835	-0.165	0.032	+/-0.3	Global	Pass

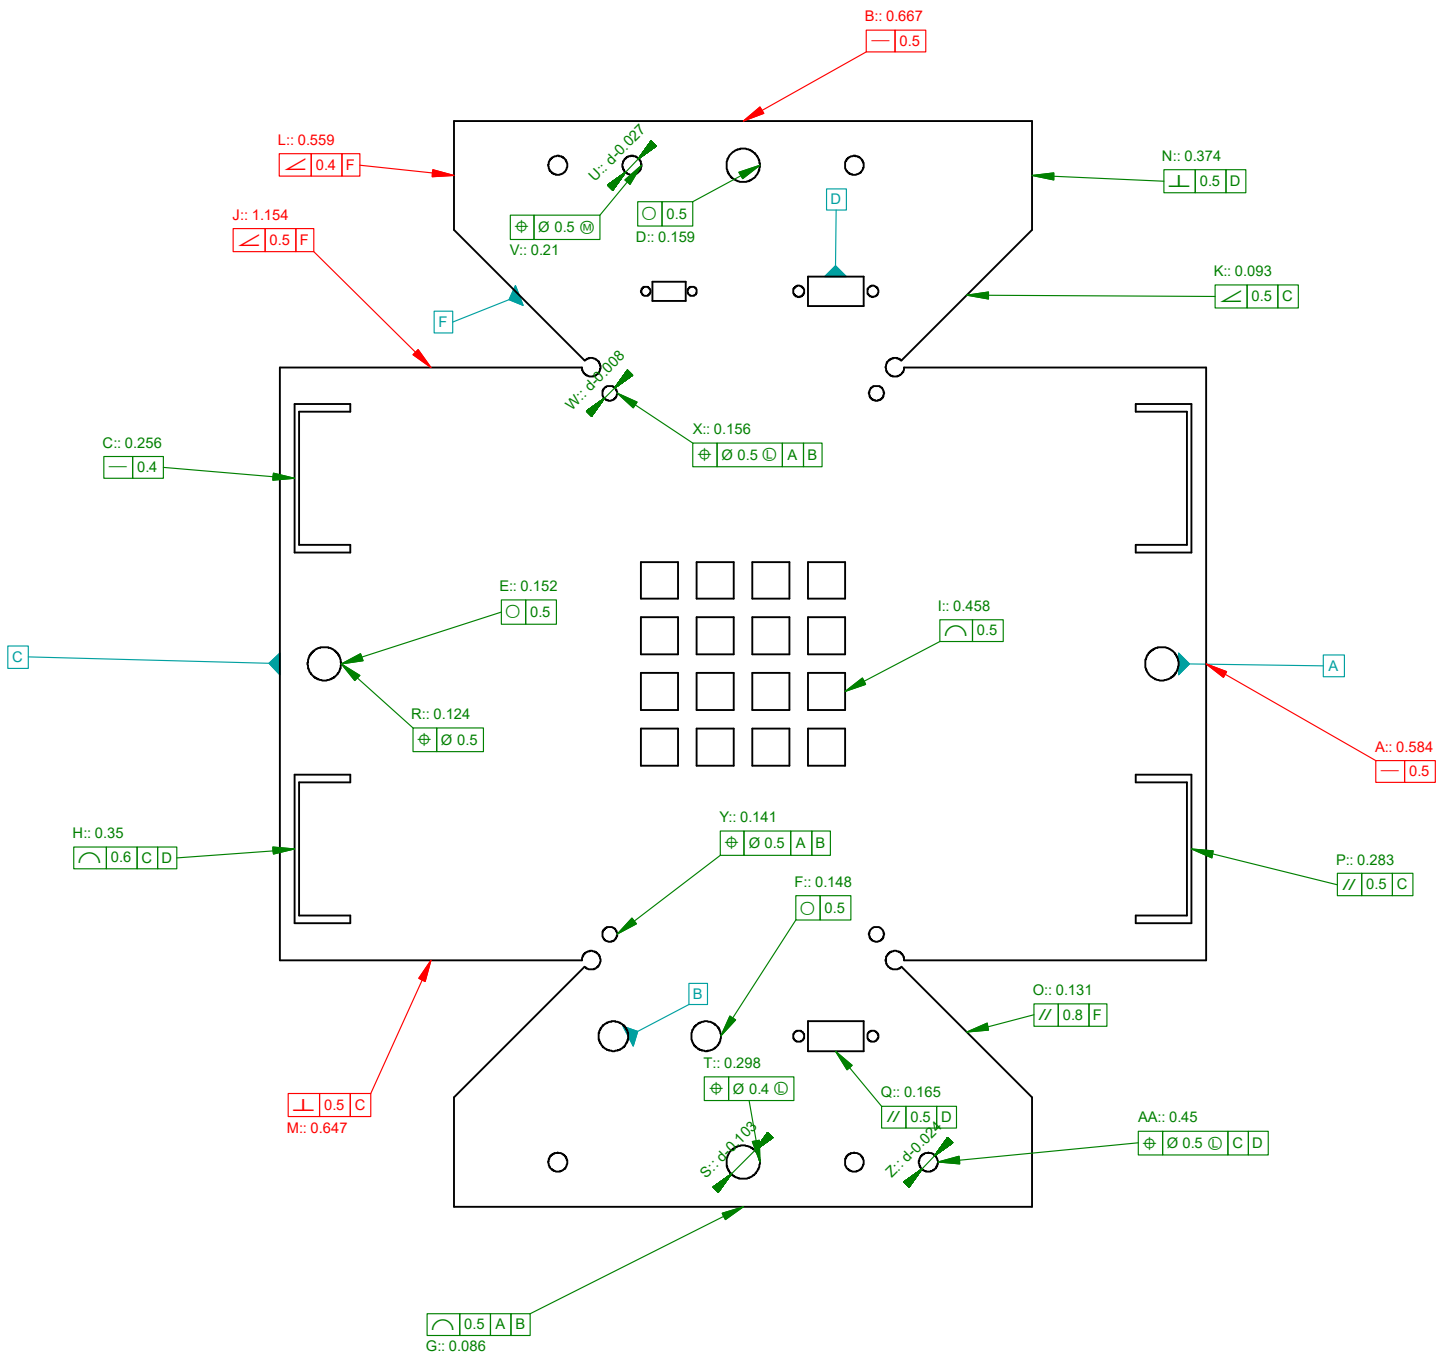
Name	Entity	Datum	Type	Nominal	Measured	Deviation	Standard deviation	Tolerance	Alignment	Status
A	Line		Straightness	0	0.584		0.03	0.5		Fail
B	Line		Straightness	0	0.667		0.022	0.5		Fail
C	Line		Straightness	0	0.256		0.021	0.4		Pass
D	Circle		Circularity	0	0.159		0.035	0.5		Pass
E	Circle		Circularity	0	0.152		0.032	0.5		Pass
F	Circle		Circularity	0	0.148		0.066	0.5		Pass
G	Line	AB	Profile	0	0.086		0.015	0.5	AB	Pass
H	Line	CD	Profile	0	0.35		0.03	0.6	CD	Pass
I	Line		Profile	0	0.458		0.029	0.5	Global	Pass
J	Line	F	Angularity	0	1.154		0.045	0.5		Fail
K	Line	C	Angularity	0	0.093		0.02	0.5		Pass
L	Line	F	Angularity	0	0.559		0.015	0.4		Fail
M	Line	C	Perpendicularity	0	0.647		0.03	0.5		Fail
N	Line	D	Perpendicularity	0	0.374		0.032	0.5		Pass
O	Line	F	Parallelism	0	0.131		0.017	0.8		Pass
P	Line	C	Parallelism	0	0.283		0.027	0.5		Pass
Q	Line	D	Parallelism	0	0.165		0.031	0.5		Pass
R	Circle		Position	0	0.124		0.032	0.5	Global	Pass

S	Circle	Circle	Dia	9	8.897	-0.103	0.059	+/-0.2	Global	Pass
T	Circle		Position	0	0.298		0.059	0.4 (L)	Global	Pass
U	Circle	Circle	Dia	5.1	5.073	-0.027	0.037	+/-0.1	Global	Pass
V	Circle		Position	0	0.21		0.037	0.5 (M)	Global	Pass
W	Circle	Circle	Dia	4	3.992	-0.008	0.033	+/-0.1	AB	Pass
X	Circle	AB	Position	0	0.156		0.033	0.5 (L)	AB	Pass
Y	Circle	AB	Position	0	0.141		0.046	0.5	AB	Pass
Z	Circle	Circle	Dia	5.1	5.076	-0.024	0.067	+/-0.1	CD	Pass
AA	Circle	CD	Position	0	0.45		0.067	0.5 (L)	CD	Pass

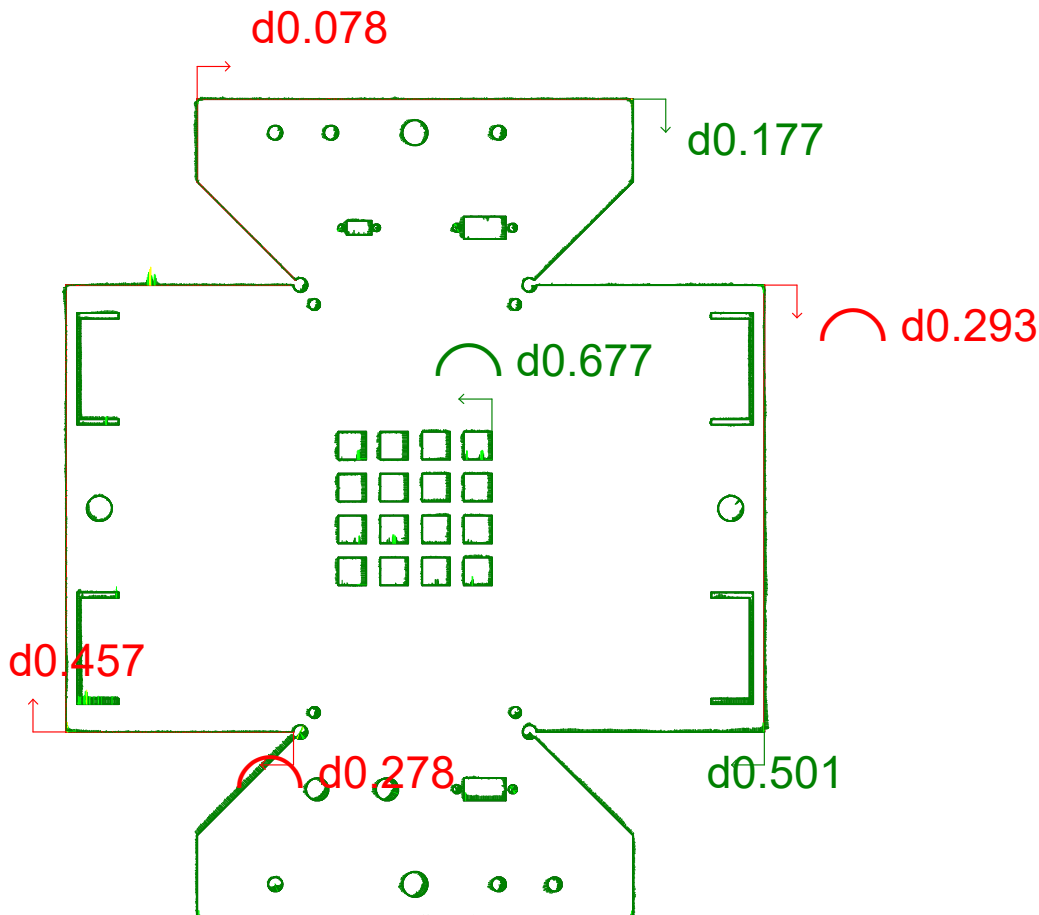
Filepath: 2D Demo Part.plr  
 Customer: Costumer Industries  
 Operator: Admin  
 Inspection Date: 03/11/2020 (12:26:58)  
 Works Order No: WON-Nr1295-b  
 Customer Order No: CoNo1265-h  
 Part No: PaNo2654  
 Customer Part No: CPN-5699866  
 Alignment: Global  
 Measurements: 13899  
 Entities: Passed: 143  
 Part Thickness: Nominal: 2

Passed: 13897  
 Failed: 7  
 Measured: 2  
 Failed: 2  
 Missing: 0  
 Deviation: 0
